FINAL REPORT, PROJECT HERMES V-2 MISSILE PROGRAM

A Report of
Guided Missiles Department
Aeronautic and Ordnance Systems Divisions
Defense Products Group
Schenectady, New York

Author WHITE, L. D.	Subject Classification MISSILES, GUIDED	No. R52A0510 Date SEPTEMBER, 1952
------------------------	--	--

Abstract THIS IS THE FINAL REPORT ON V-2 OPERATIONS CONDUCTED AT THE WHITE SANDS PROVING GROUND AS PART OF PROJECT HERMES. PRIMARY ATTENTION IS GIVEN TO THE PERFORMANCE OF THE MISSILE AND THE COMPONENTS. OPERATIONAL AND TEST PROCEDURES AS USED AT WSPG ARE DISCUSSED. THE PROGRAM WAS CONCLUDED IN JUNE 1951 AFTER 67 ROCKETS USING V-2 COMPONENTS HAD BEEN CONSTRUCTED, TESTED, AND LAUNCHED.
--

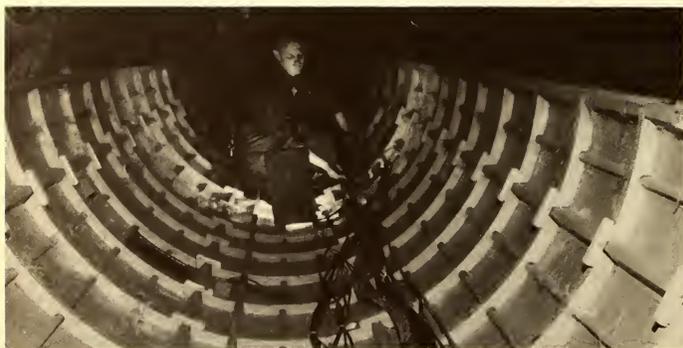
The midsection shells (Fig. 12) were generally in fair condition. In many cases the skin was torn, and patching was frequently required, but the ribs and longitudinal members seldom showed serious damage. Since there was a surplus of about 25 percent from which to select, major repairs were not required.

Fig. 12 Control Cables Being Laid
in V-2 Midsection

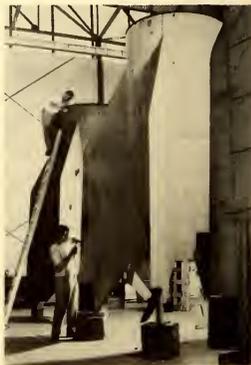
A few extra tail units (Fig. 13) were received but several, out of the total, were damaged beyond repair. Some obviously had been damaged in Germany prior to being crated, certain units were damaged by handling and a few were damaged by wind and weather.

Fig. 13 V-2 Tailsections at WSPG

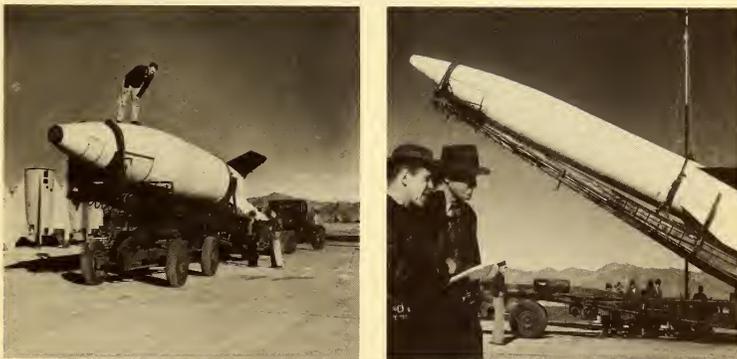
In general, this device was well designed for field use, but it had two objectionable features. First, the hydraulic system required excessive maintenance, partially due to the exposed pistons. Second, it did not always position the missile properly on the launching stand. In an attempt to insure proper positioning, the Meilerwagen was coupled to the platform prior to erection. If the coupling was tight enough to position the missile accurately, it was difficult to mesh with the Meilerwagen. If it was loose enough for easy meshing, the position of the missile might be unsatisfactory. Thus, either extreme, or any compromise in between, was likely to result in excessive erection time.

Fig. 16 Left to Right, Meilerwagen used for Transporting and for Erecting the V-2. Figure 20 shows this Unit in the Vertical Position.

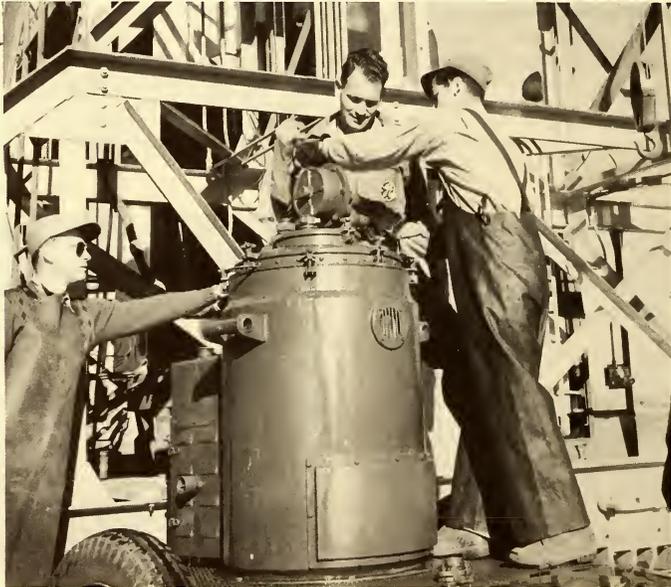
This trailer (Fig. 17) had provisions for warming the peroxide and for pumping it to a measuring tank on the Meilerwagen. The peroxide was surrounded by a water jacket; water was heated by a gasoline heater. Pumping was by a hand pump which was a constant source of trouble.

Since the heater was not required at WSPG and since the pump was poor, the use of the trailer was discontinued. Peroxide was ordered in exact quantities so that two drums made one charge. These drums were hoisted to a platform about ten feet above the missile peroxide tank and the peroxide loaded by gravity feed.

Fig. 17 German Hydrogen-Peroxide Trailer Used to Load V-2 Missile at WSPG

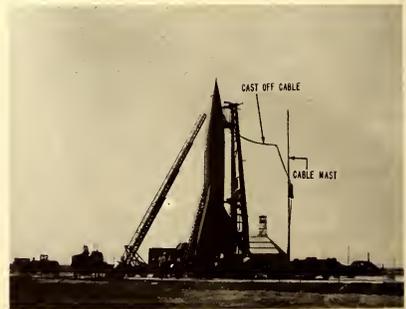
To keep missile weight at a minimum, the ground control wires were connected to the top of the missile by external cables (Fig. 20) which were cast off just prior to lift. The cables terminated at the lower end in Flak plugs of the type previously described. At the missile end a "Stotz" plug was used. A special cable, having exceptional flexibility, aided in the process of casting the plugs free.

The Stotz plug had adequate space for fanning the cables to the contacts, and the contacts themselves were excellent. An appreciable amount of trouble was experienced with these plugs, but it should be noted that they were subjected to very severe duty. The release mechanism was simple and effective. The only unfavorable feature was the fact that its gear sector showed excessive wear.

Fig. 20 V-2 Being Erected for Launching

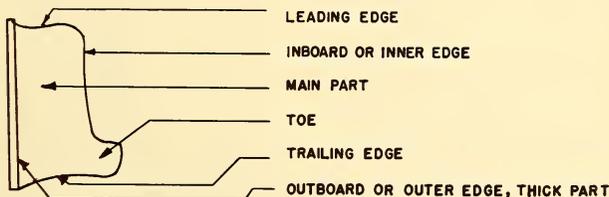
Fig. 28 Jet Vane Descriptive Terms

c. The location of a fault is also important, particularly if it is in a critical area, such as the leading edge of the main part of the vane or of the toe, particularly near the outboard corners. The descriptive terms in Figure 28 are suggested.

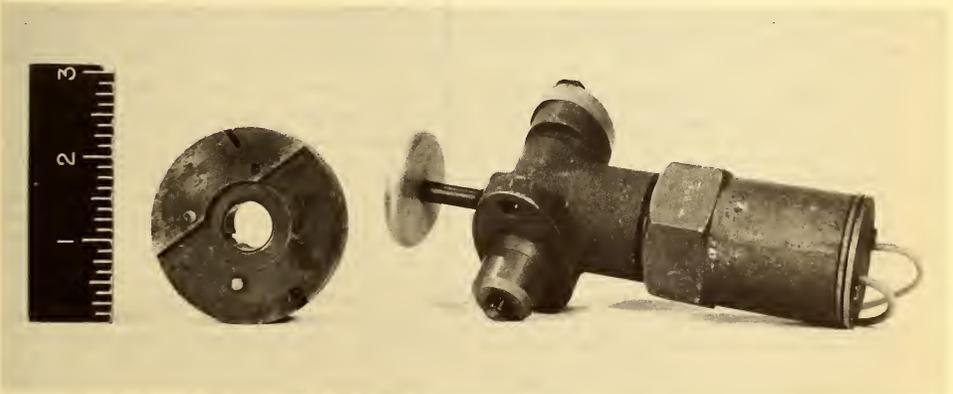
Fig. 32 V-2 Turbopump Overspeed Trip

i. Overspeed Assembly: A test determined the speed at which the overspeed trip ring began to move out as compared to the speed at which the overspeed trip ring had moved completely out. It was found that once the trip ring had begun to move out, it would probably move completely out at that same speed and would definitely be completely out at 200 additional rpm's.

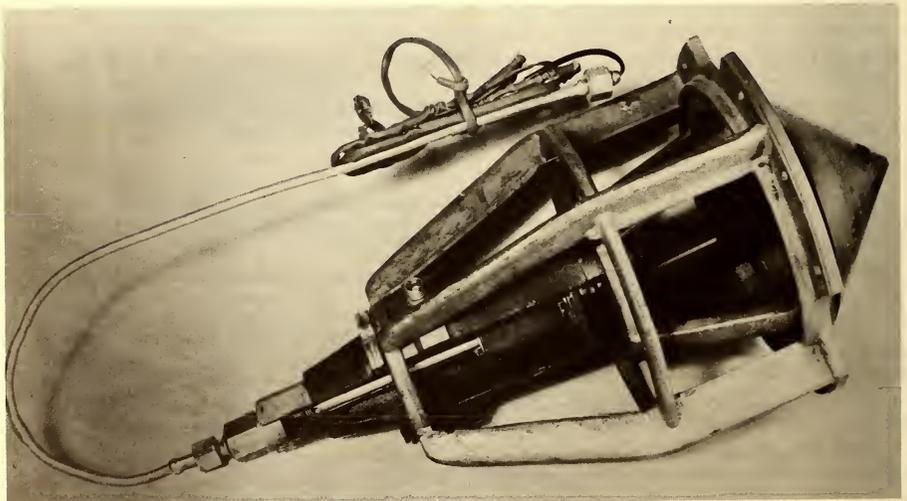
Fig. 38b Alcohol Preliminary Valve

Although many and varied defects were noted, there was no instance in which the valve failed to operate. There were, however, many instances of very rough strokes. Disassembly of these valves showed a scoring on the center cylinder where the stem-nut moved. In some instances, this scoring was quite severe (pieces of aluminum had been rubbed off the cylinder). This was probably caused by manufacturing errors, either in tolerances or in alignment. To make certain that sticky "U" cups were not causing rough strokes, two valves with rough strokes were disassembled and a graphite base lubricant ("Aquadag") was applied to the surfaces that would be in contact with the "U" cups. When reassembled, the valves continued to operate with rough strokes. A rough stroke in this valve was serious for two reasons. First, it indicated that a rubbing between two metal surfaces existed which might result in a complete seizure at a later time. Second, it might cause a missile failure at takeoff (explained in the oxygen main valve section of this report). A minor design change to increase the clearance between the center cylinder and the stem nut, to provide no contact between the two units, would probably have eliminated the rough stroke. This would have necessitated inserting a thrust washer on top of the spring and increasing the inside diameter of the stem.

At one time, control air leakage was consistently appearing at the large nut on top of the valve, indicating that the gasket between the cylinder and case was not sealing correctly. It was noted that the installation and tightening of the return line rotated the cylinder to the extent allowed by the Woodruff key, this loosened the nut by that amount. Tightening the large valve nut after the return line was tightened corrected the difficulty.

There was one instance of leakage past the main seat of the valve. This was caused by a flat spot on the knife-edge of the burner. A second valve was installed and no leakage was detected past the seat. Although no hardness tests were made, it was assumed that the rubber composition was softer on the second valve than it was on the first.

In the initial assembly of the valve (during manufacture) a small hole was drilled through the top locking nut and into the cylinder to take the spring locking clip. In one instance, the hole was drilled completely through the cylinder. This defect was not noticed until alcohol was observed leaking from the midsection.

During one valve bench-test, a threaded nut on the bottom of the valve stem pulled away from the valve cone. To determine the average strength of these connections, three valves were tested by securing the covers to the bodies and applying control pressure. In all three cases, 2000 psi control pressure was insufficient to break the stems loose from the cones. It was never determined why the one stem nut was so weak. The valve stems on about 30 percent of the valves were pitted and/or corroded.

In almost every valve, the "U" cups had taken a permanent set and would not seal control air. Spare German "U" cups were available at WSPG. These were invariably good and would seal, except when the cylinder or push rod was defective.

The vertical air inlet fitting elongated badly with moderate torque. Although no failures occurred, there was considerable necking; replacement parts of steel were utilized. If it was thought necessary to use aluminum for the new fittings, smaller diameter elongated holes placed vertically so that the metal cross-sectional area through the holes was greater, would have been utilized. Also, a heavier-walled fitting could probably have been adopted.

The valves were assembled in Germany with solid conductor switch leads. These were changed to stranded wire after the first 20 to 25 firings at WSPG. The aluminum tubes were replaced with copper tubes for ease in installing the new wire.

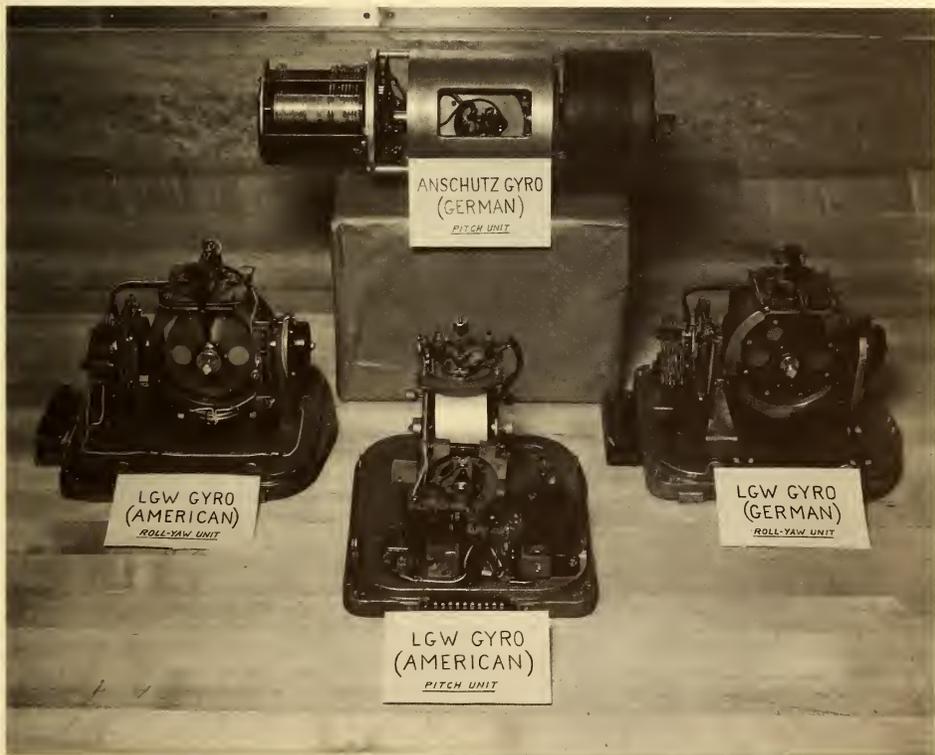
Fig. 57 German and American-made Gyros Used in the V-2 Project at WSPG

During the early part of the V-2 program, the availability of usable control gyros was a serious problem. There were two main types Anschutz and LGW (Fig. 57) available from Germany. However, most of these units were in such poor condition that a general rebuilding was necessary. Both types were used to some extent at WSPG, at times with a pitch gyro of one type and a roll yaw of the other type on the same plate.

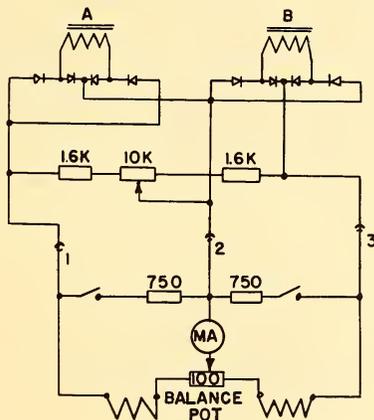
Fig. 60 Computer Output Windings

Considered most important were the unbalance and load tests. In the former, the balance pot shown in Fig. 60 was turned to the limits on each side. The current unbalance indicated on the meter should have been 5 ± 2 ma. In the load test, a 750-ohm resistor across one leg of the three control-current leads should have resulted in 9 ± 2 ma. During laboratory tests the computers were tuned to meet these conditions. Results obtained on American computers prepared for firing are included in Table VIII. The differences shown in Table VIII were evident in all American computers tested. Results of the 750 ohm tests were just as variable between the laboratory and rocket installation.

From Fig. 60 it can be seen that if an unbalance of 10 ma existed in the circuit due to a control signal applied from the computer through windings A and B, a difference of 14 ohms should not cause a change in the current of more than one-half of one percent. Yet, in the actual operation of a computer, changing the servo had caused a variation in current up to 100 percent.

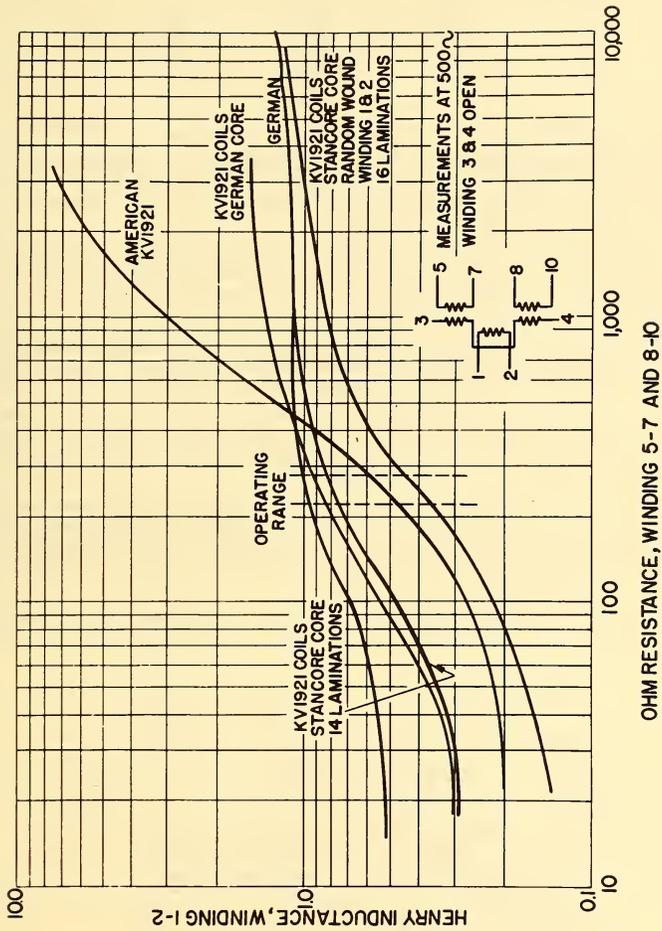
Fig. 62 Inductance in Windings 1 and 2 Versus Resistance in Windings 5-7 and 8-10

Figure 62 is a log-log plot of the inductance of control winding 1-2 versus the resistance on windings 5 to 7 and 8 to 10. Attention should be directed to the slope of the curves labeled American KV1921 and German, over the operating region. This section is considered the operating range since the load of the servo valve coils fall between these points. The change of inductance in the American transformer is quite large as compared with the German when the loading varies between 220 to 280 ohms.

In an effort to pinpoint the trouble, a KV1921 and a German transformer was disassembled. The German core was inserted in the American windings. Test results are shown in Fig. 62. In addition, laminations from a Stancore Input Transformer, Type A-53-C was found to fit the windings from a KV1921. Test data are included in Fig. 62.

In general, it was felt that the type KV1921 transformer was the offending unit and if made to conform more closely with the German output transformer, better operation would result.

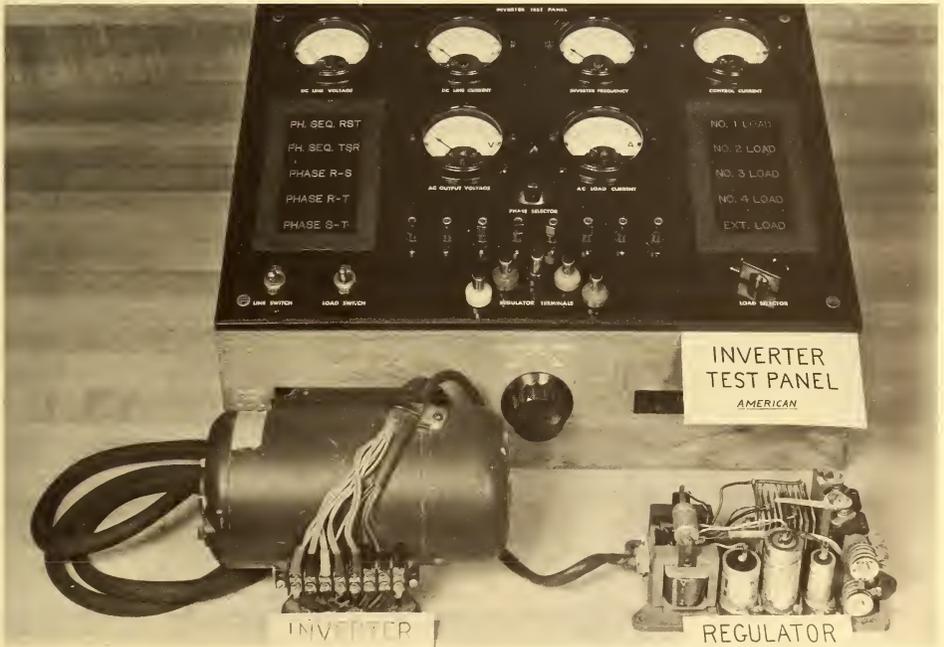
Fig. 69 Inverter Regulator and Test Panel

The inverter and regulator set proved to be a very dependable unit. It supplied 500 cycle a-c power for operation of the gyro motors and the missile servo amplifier. The inverter unit consisted of a d-c adjustable-speed motor driving an alternator with a six-pole permanent-magnet rotor and a wound stator. The regulator was a rather unique unit with no moving parts. The frequency sensitive portion of the circuit consisted of two inductance-capacitance tuned circuits, one tuned slightly above 500 cps and the other tuned slightly below 500 cps. In series with each of these tuned circuits was a bridge rectifier circuit. Direct-current from these rectifiers flowed through two saturable reactors which controlled flow of a-c current into another rectifier, the output of which operated the control field of the d-c motor driving the inverter. Each tuned circuit tended to make the inverter operate at its frequency. This system held the frequency to about one-tenth of one percent with as much as 10 percent change in line voltage. Adjustment was obtained by changing one of the adjustable inductors. Difficulties with the inverters and regulators consisted mostly of sparking at the brushes of the inverter and poor soldering or broken connections in the regulator. Radio interference was encountered a few times but seemed limited to individual cases where brush sparking was a little worse than usual. Since there was a large supply of these inverters, no attempt was made to repair an occasional troublesome unit. The original German wiring system used a List 14 pole plug. Because the supply of the matching plug was limited, the plugs were removed and an American terminal board substituted. The inverter, regulator and test panel are shown in Fig. 69.
